Recording date: 2/3/09

Type **Hotel**

Name **HOTEL ALBANI FIRENZE**

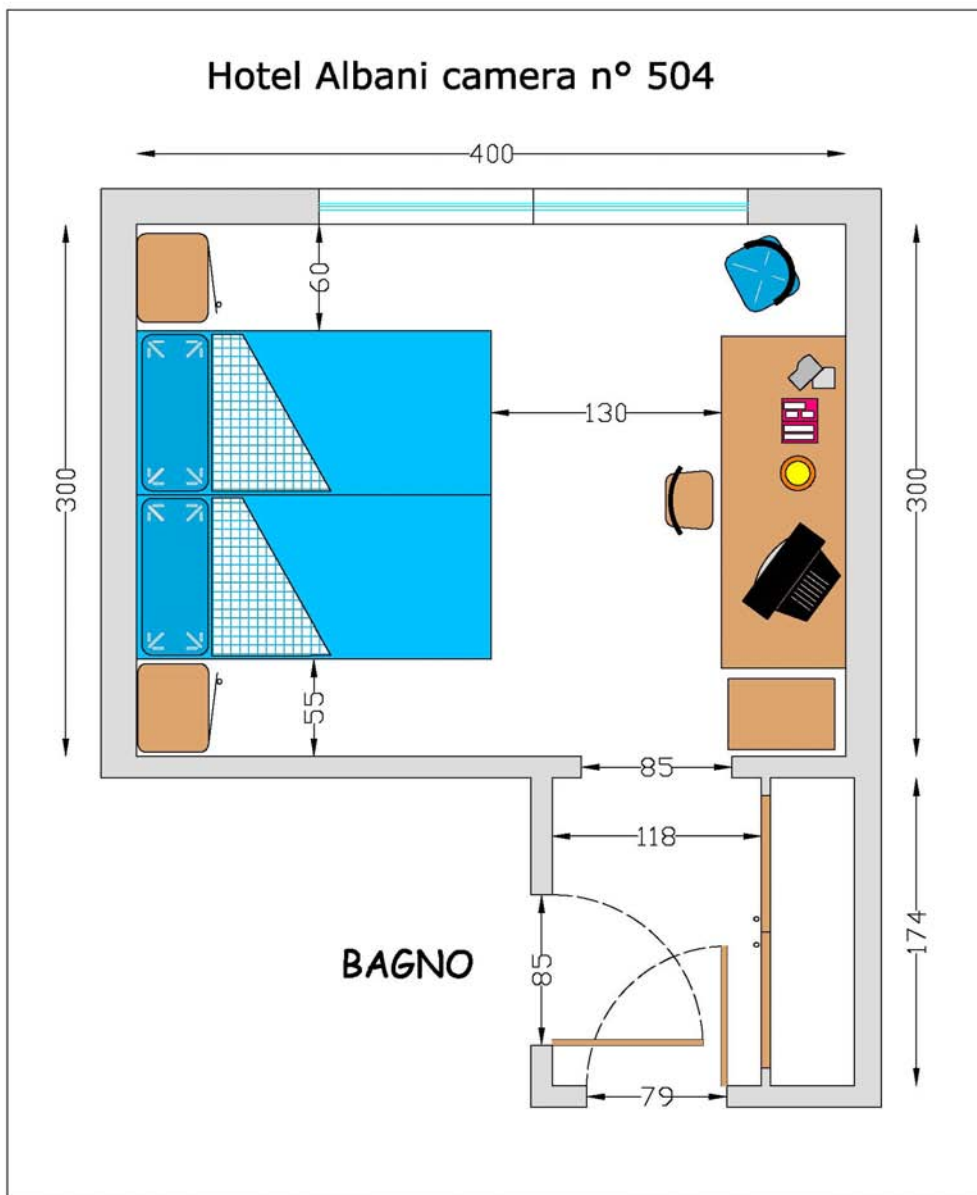
FLOOR PLAN

Number - Name: 504

Width of entrance door cm 79

Is there sufficient space for wheel-chair rotation ? No

Narrowest passage, cm 55

Description: between the bed and the wall
