Recording date: 2/3/09

Name **HOTEL BEATRICE**

GENERAL SUMMARIZING NOTES DESCRIBING THE STRUCTURE

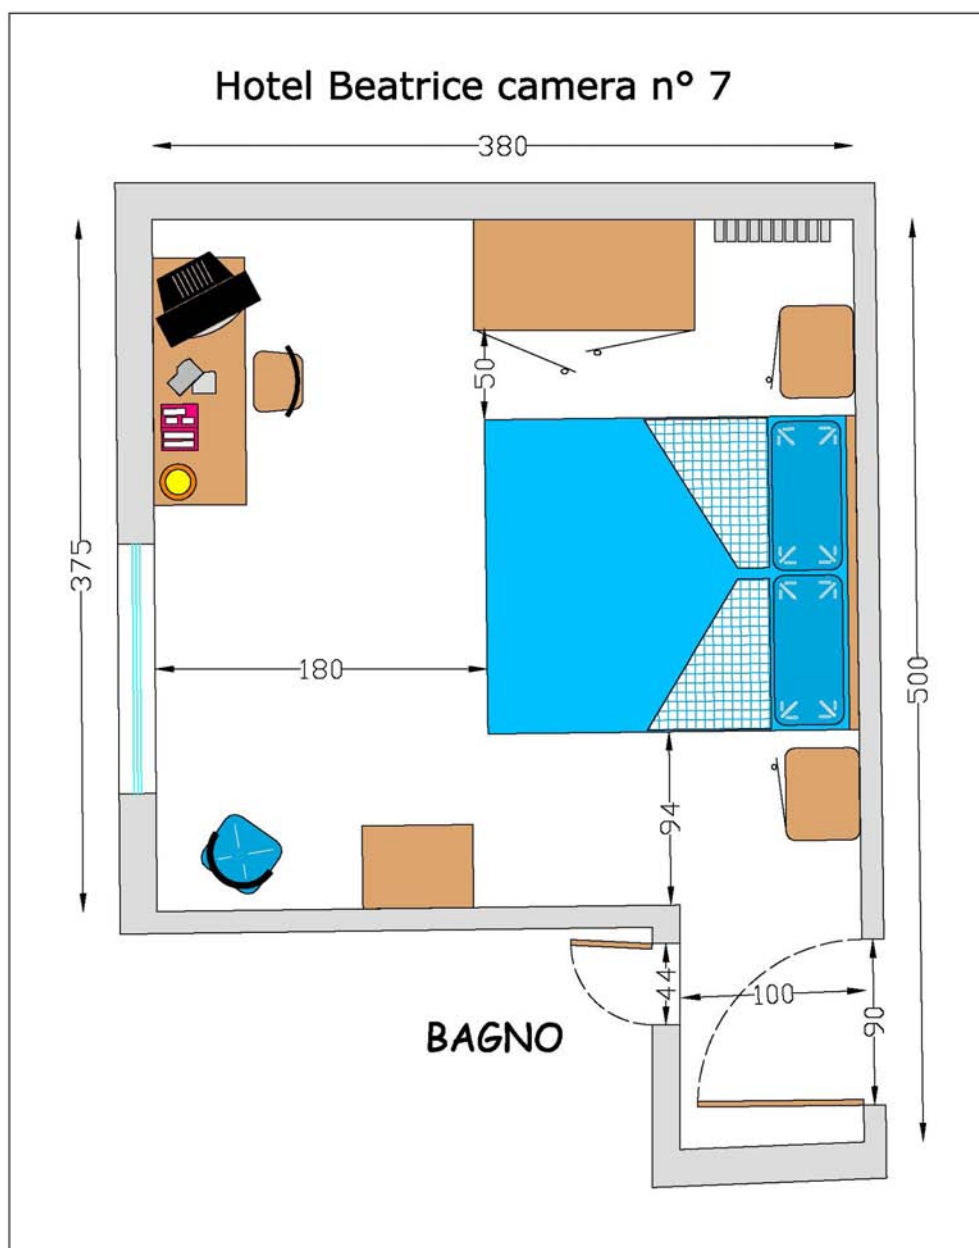
FLOOR PLAN

between the furniture and the wall

between the room and the internal bathroom

Accessible rooms are on the second floor.
Room numbers are: 2, 4 similar in
disposition and dimensions to room 7.

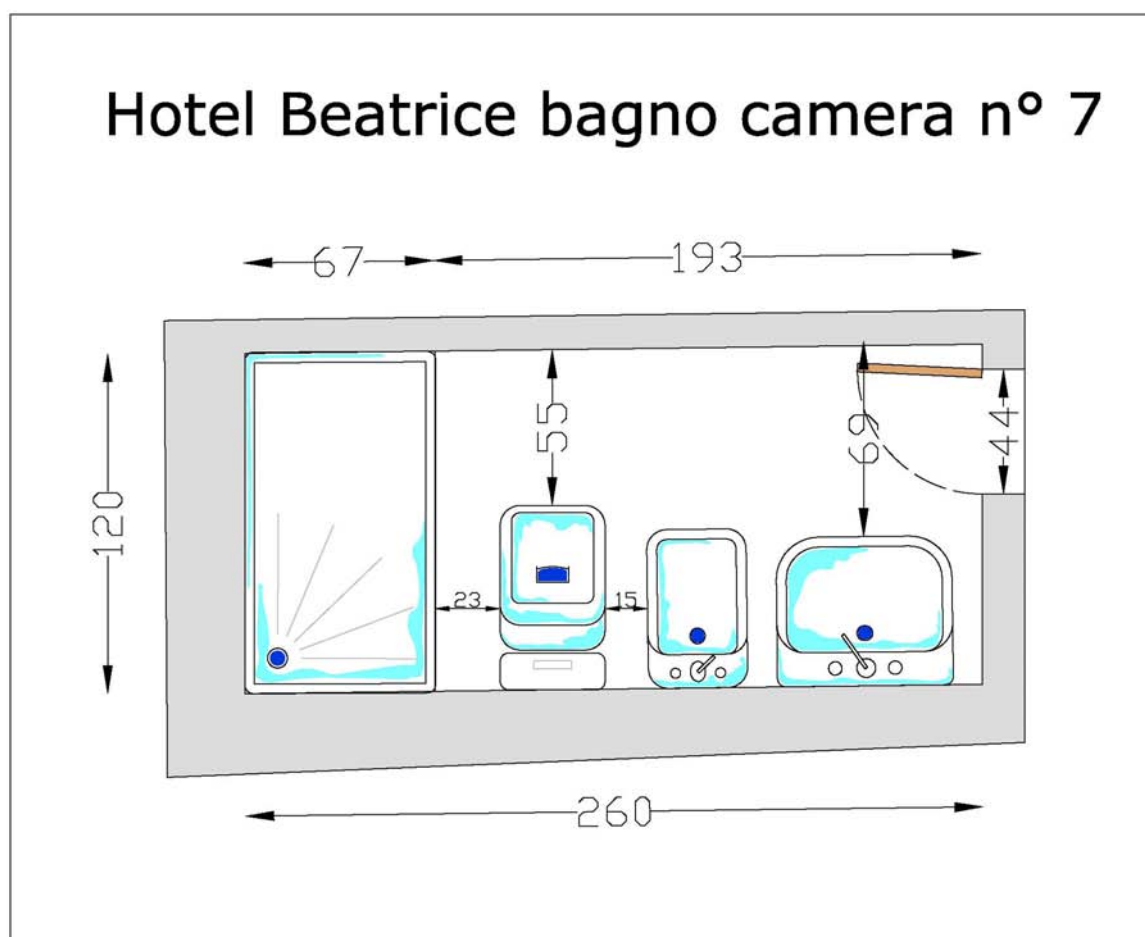
CARD DB_WC/BATHROOM/RESTROOM

Number - name: 007

Shower?	Yes	
Type of shower:	box shower with entrance cm.	
Shower provided with seat?	No	
Type:		
Shower provided with handles?

The bathroom has a 10 cm step.

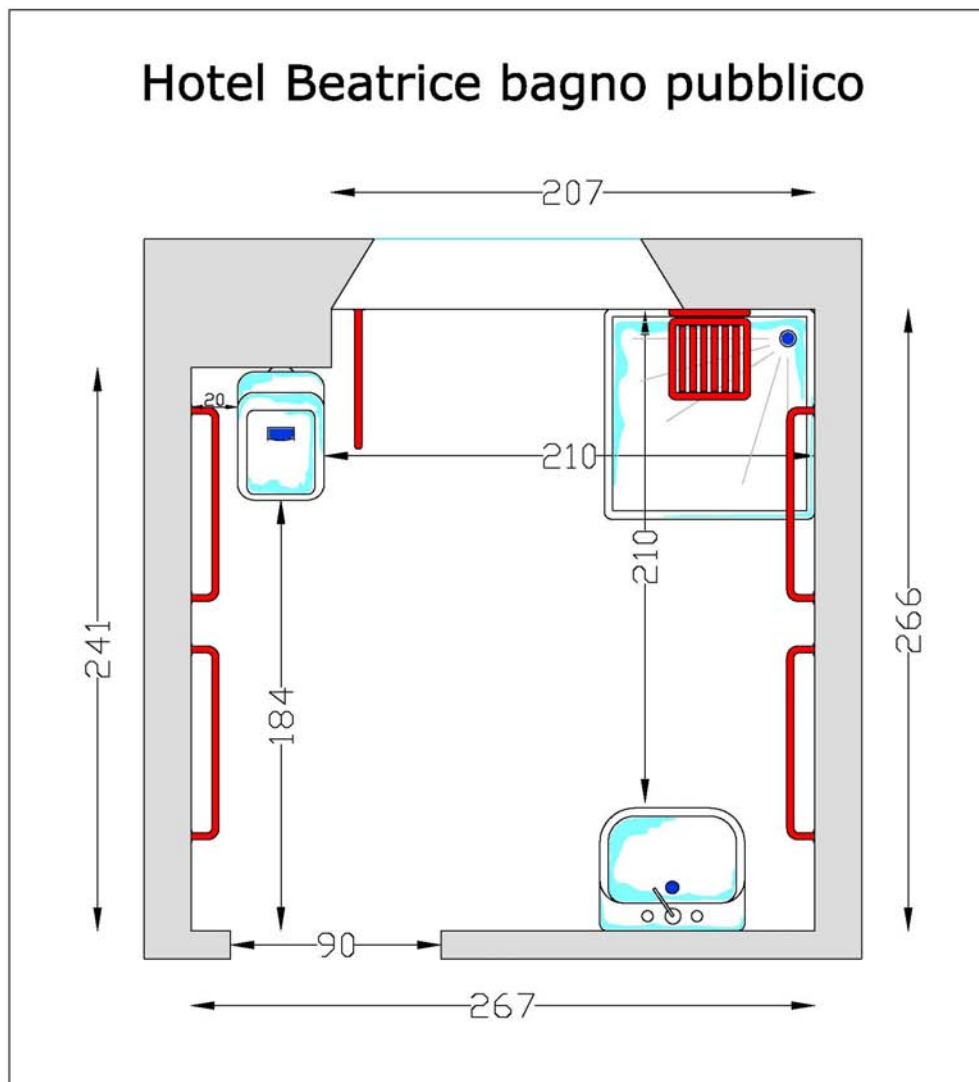
CARD DB_WC/BATHROOM/RESTROOM

Shower?	Yes	
Type of shower:	on floor	
Shower provided with seat?	Yes	
Type:	drop seat	
Shower provided with handles?	Yes

The bathroom is public, but dedicated in particular to disabled who cannot use the bathroom inside their room, because narrow and with a 10 cm entrance step.
