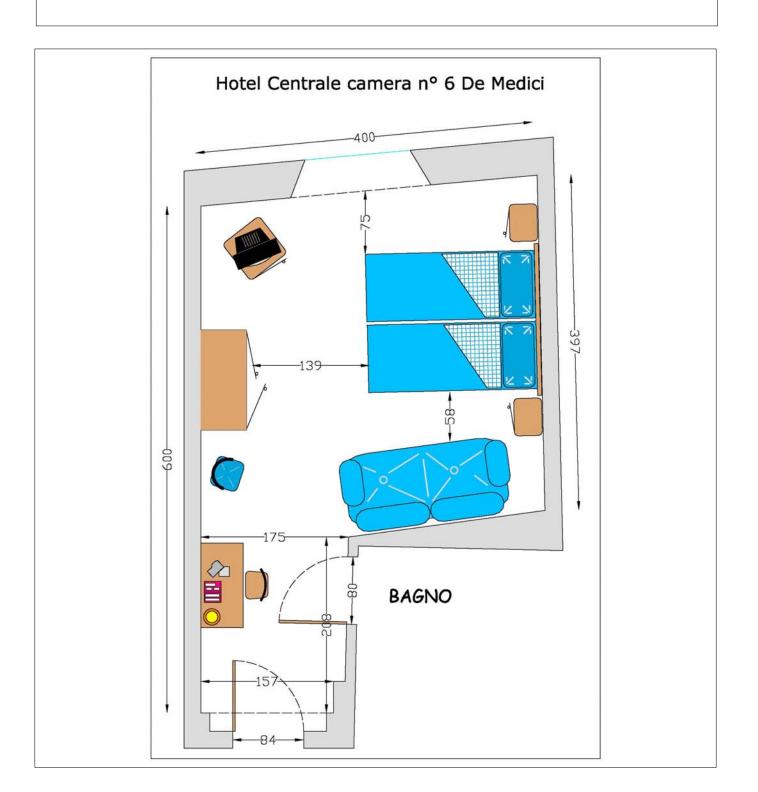
Туре:	hotel			
Number - Name:	6 / De Medici			
Situated on floor:	second			
Type of room:	Twin			
Anti-allergenic room? No	Yes:			
The room is: No smoking				
The room is: No smoking				
Width of entrance door cm	84			
Internal door, cm				
Other:				
Is there sufficient space for whee	el-chair rotation ?	Yes		
Other:				
Narrowest passage, cm	58			
Description:	between the co	uch and the bed		
Presence of carpeting?	No			
Are there internal stairs?	No			
Where?				
Is it possible	to move the bed?	Yes		
	Bed height, cm	54		
Is it possible to me		No		
	from cm to cm

Is it possible to mo	ve the furniture?	Yes		
Is there a bathroom in the room?	Yes			
Bath on the floor at a distance of mt				
Is th	ere a telephone?	Yes		
Alarm system:	no			
Are there obstacles along the passagew to the	ay from the room emergency exit?	No		
Which?				
Where do the escape routes lead to:	inaccessible em	nergency exit		
lotes:		LEVEL OF SATISFACTION (OF NEEDS	
		Person with food allergies	Ŷ	
		Person with allergies	Ŷ	Partial
		Family with children in stroller/pram	N EM	Good
		Obese person or pregnant woman		Good
		Elderly, lame, heart patient		Good
		Deaf or hearing impaired person		Partial
		Blind or visually impaired person	Å.	Partial
		Person in wheel-chair with companion	A	Good
	l l

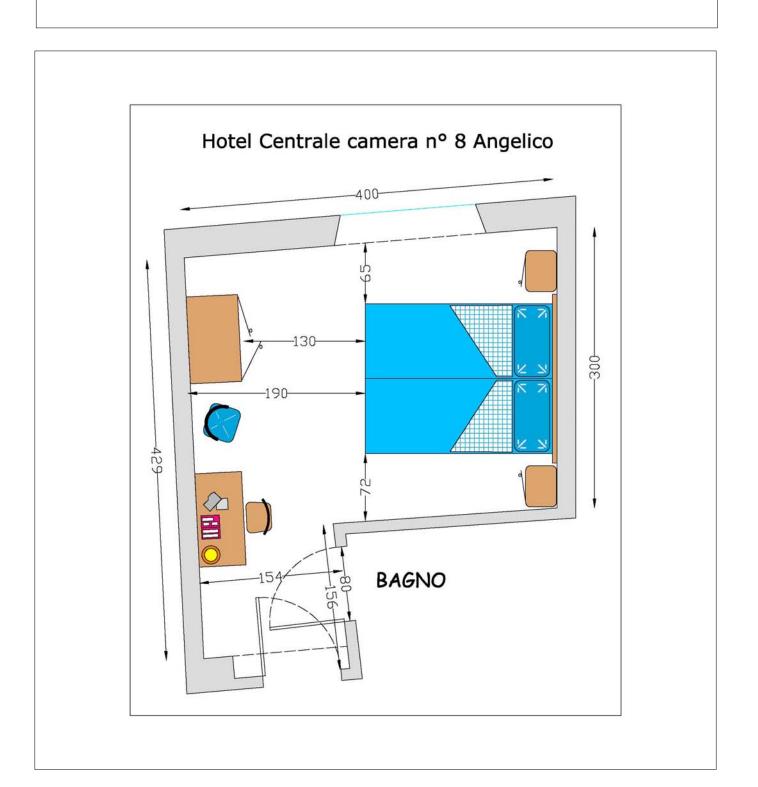
Туре:	hotel			
Number - Name:	8 / Angelico			
Situated on floor:	second			
Type of room:	Double			
Anti-allergenic room?	Yes:			
The room is: Non fumatori				
No smoking				
Width of entrance door cm	84			
Internal door, cm				
Other:				
Is there sufficient space for whee	el-chair rotation ?	Yes		
Other:	Moving furnishing	ng		
Narrowest passage, cm	63			
Description:	tra letto e muro			
Presence of carpeting?	No			
Are there internal stairs?	No			
Where?				
Is it possible	to move the bed?	Yes		
	Bed height, cm	54		
Is it possible to me		No		
	from cm to cm

Is it possible to mov	ve the furniture?	Yes		
		1		
Is there a bathroom in the room?	Yes			
Bath on the floor at a distance of mt				
Is the	ere a telephone?	Yes		
Alarm system: آ	no			
Are there obstacles along the passagewa to the e	y from the room emergency exit?	No		
Which?				
Where do the escape routes lead to: i	inaccessible en	nergency exit		
Notes:		LEVEL OF SATISFACTION (OF NEEDS	
		Person with food allergies	Ŝ	
		Person with allergies	Ŝ	Good
		Family with children in stroller/pram	A self	Good
		Obese person or pregnant woman		Good
		Elderly, lame, heart patient		Good
		Deaf or hearing impaired person	\mathcal{L}_{α}	Partial
		Blind or visually impaired person	A.	Partial
		Person in wheel-chair with companion	M	Good
	1 1		Σl	Partial

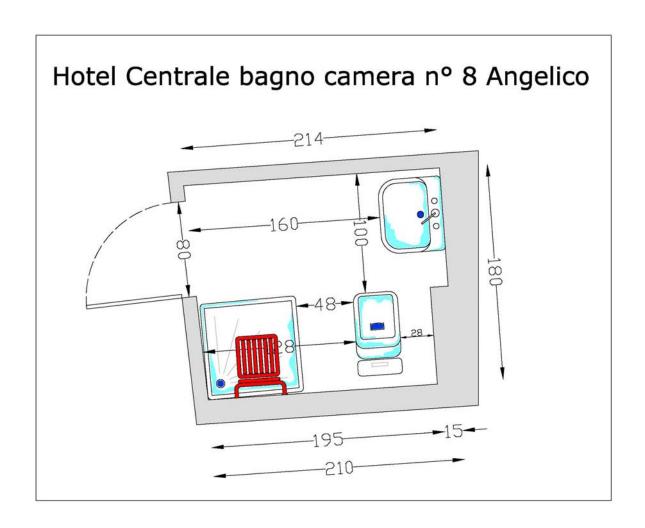
HOTEL CENTRALE			
Service:			
In:	room	Number - name: 008	
Situated on floor:	second		
Anteroom?	-No		
Entrance door, cm			
Basin?			
Туре:			
Type of basin faucet:			
Space in front of the faucet, cm			
		7	
Presence of:	-Bathroom		
Entrance door, cm	80		
Basin?	Yes		
Туре:	suspended		
Type of basin faucet:	lever		
Space in front of the faucet, cm	160		
Type of toilet:	floor toilet		
Space in front of toilet, cm	100		
Space to the right of toilet, cm	28		
Space to the left of toilet, cm	128		
Height of toilet, cm	50-52		
Bidet?	No		
Handles to the right of toilet?	No		
Handles to the left of toilet?	No

Shower?	Yes
Type of shower:	box shower with entrance cm. on floor
Shower provided with seat?	Yes
Туре:	removable
Shower provided with handles?	Yes
Bathtub?	No
Туре:	
Provided with internal seat?	
Provided with handles?	
Provided with lifter?	
Model:

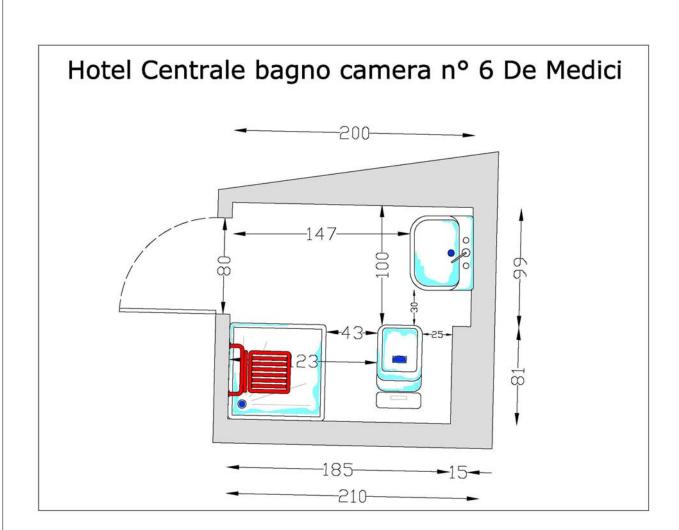
HOTEL CENTRALE			
Service:			
In:	room	Number - name: 006	
Situated on floor:	second		
Anteroom?	-No		
Entrance door, cm			
Basin?			
Туре:			
Type of basin faucet:			
Space in front of the faucet, cm			
		7	
Presence of:	-Bathroom		
Entrance door, cm	80		
Basin?	Yes		
Туре:	suspended		
Type of basin faucet:	lever		
Space in front of the faucet, cm	147		
Type of toilet:	floor toilet		
Space in front of toilet, cm	30		
Space to the right of toilet, cm	25		
Space to the left of toilet, cm	123		
Height of toilet, cm	50-52		
Bidet?	No		
Handles to the right of toilet?	No		
Handles to the left of toilet?	No

Shower?	Yes
Type of shower:	box shower with entrance cm. on floor
Shower provided with seat?	Yes
Туре:	removable
Shower provided with handles?	Yes
Bathtub?	No
Туре:	
Provided with internal seat?	
Provided with handles?	
Provided with lifter?	
Model:
