Recording date: 2/3/09

Name **HOTEL CORONA**

Address **VIA NAZIONALE, 14**

Town **FIRENZE**

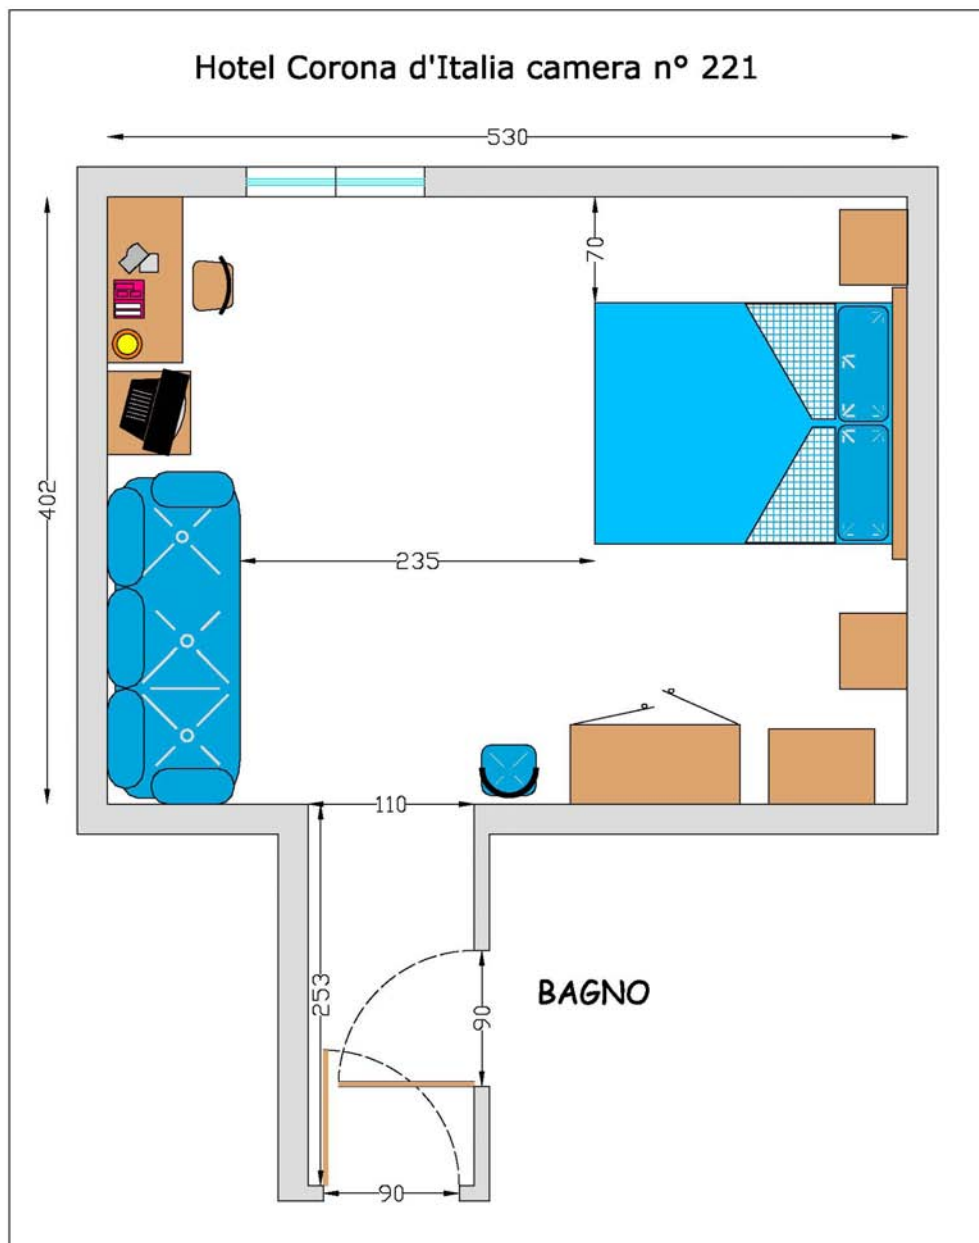
# FLOOR PLAN

70

between the wall and the bed

Accessible room numbers are: 221, 321 (double), 223, 224, 323, 324 (twin), similar in disposition and dimensions.

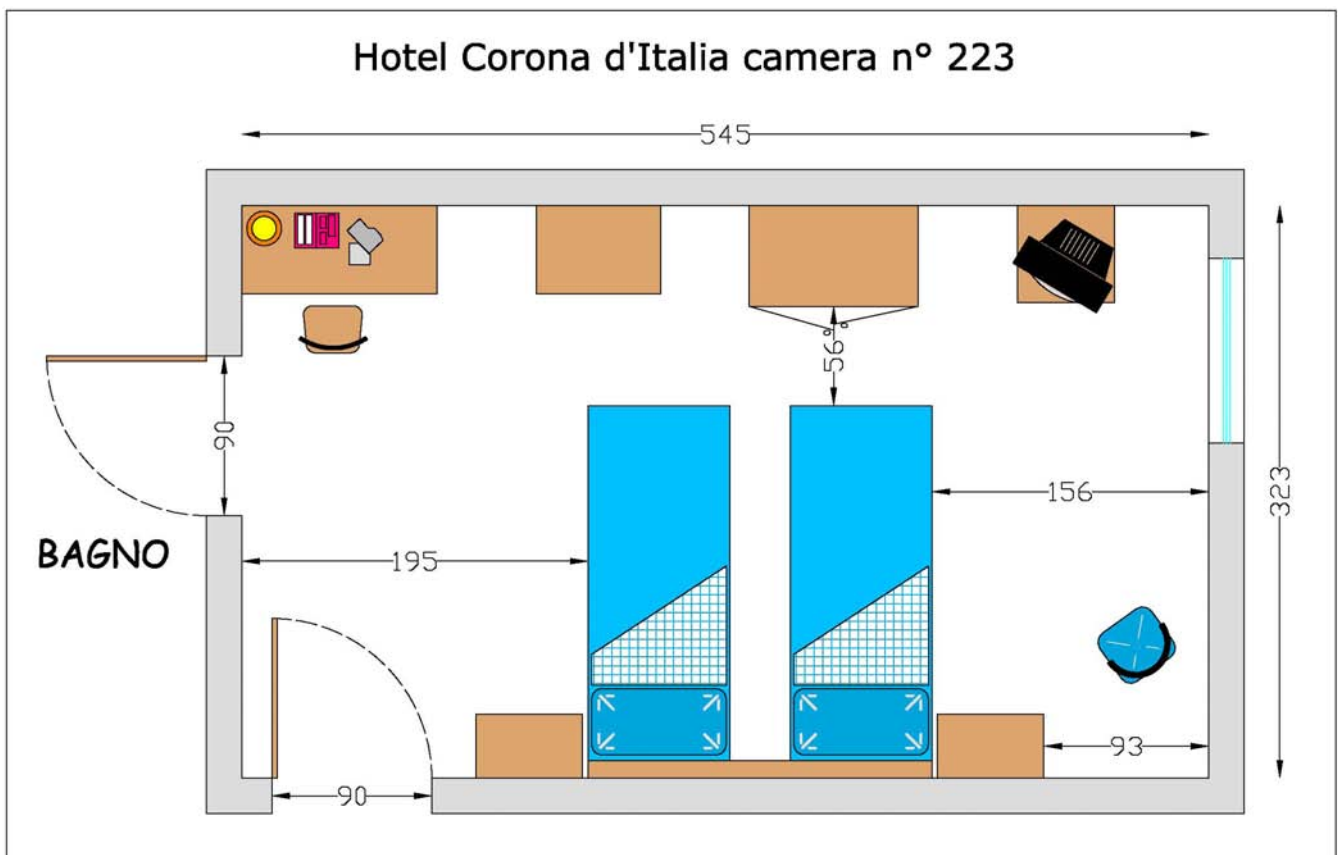
Which side of the structure does the floor plan refer to?

56

between the furniture and the bed

Accessible room numbers are: 221, 321 (double), 223, 224, 323, 324 (twin), similar in disposition and dimensions.

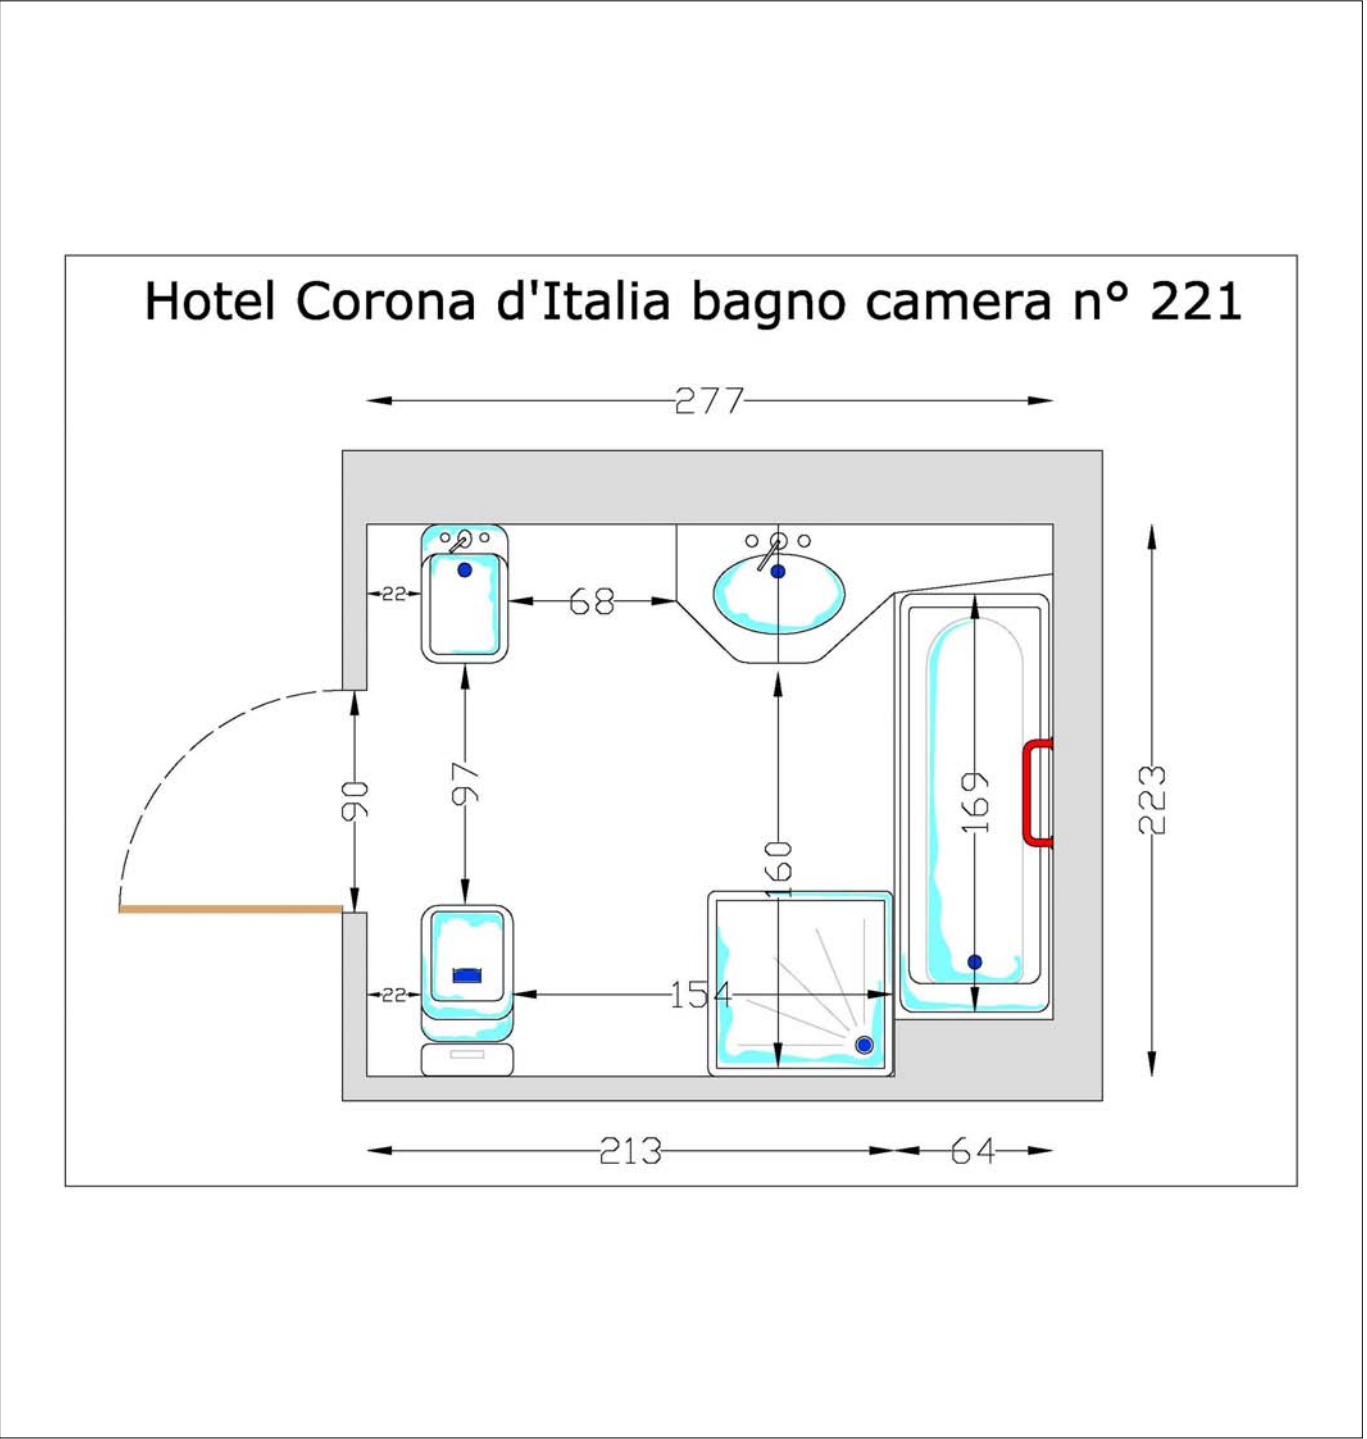
Shower?	Yes	
Type of shower:	on floor	
Shower provided with seat?	No	
Type:		
Shower provided with handles?	No

Bathtub?	Yes	
Type:	Bathtub with shower	
Provided with internal seat?	No	
Provided with handles?	Yes	
Provided with lifter?	No	
Model:

Large bathroom and good internal mobility.

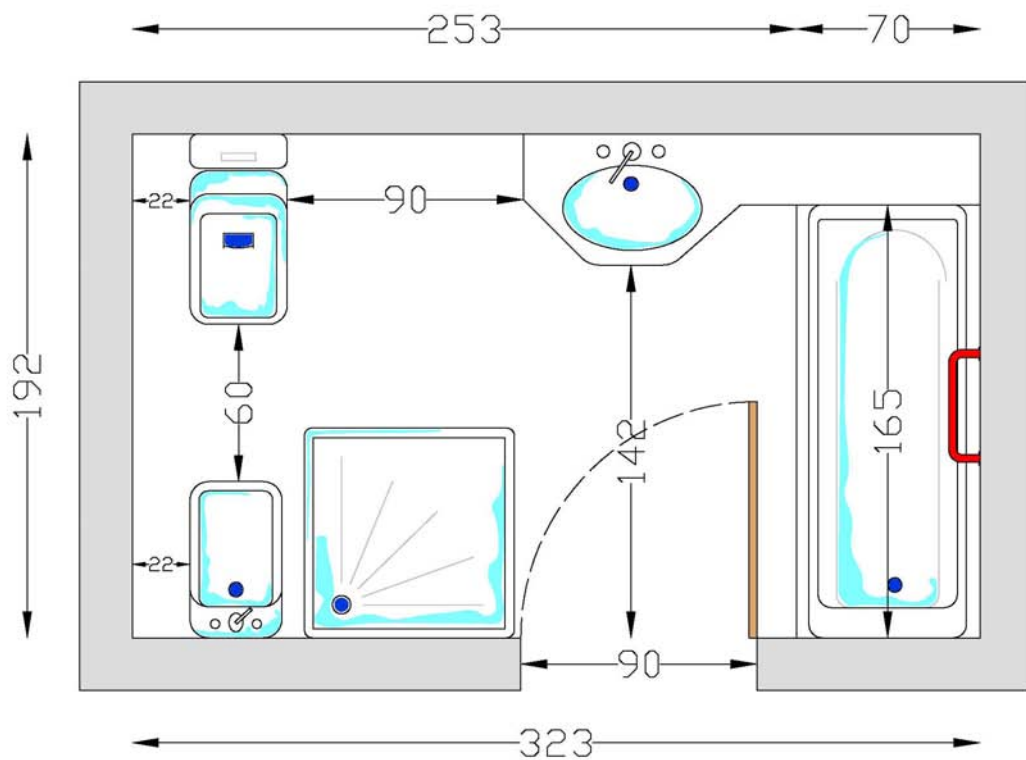
## Hotel Corona d'Italia bagno camera n° 223

Shower?	Yes	
Type of shower:		
Shower provided with seat?	No	
Type:		
Shower provided with handles?	No

Bathtub?	Yes	
Type:	Bathtub with shower	
Provided with internal seat?	No	
Provided with handles?	Yes	
Provided with lifter?	No	
Model:

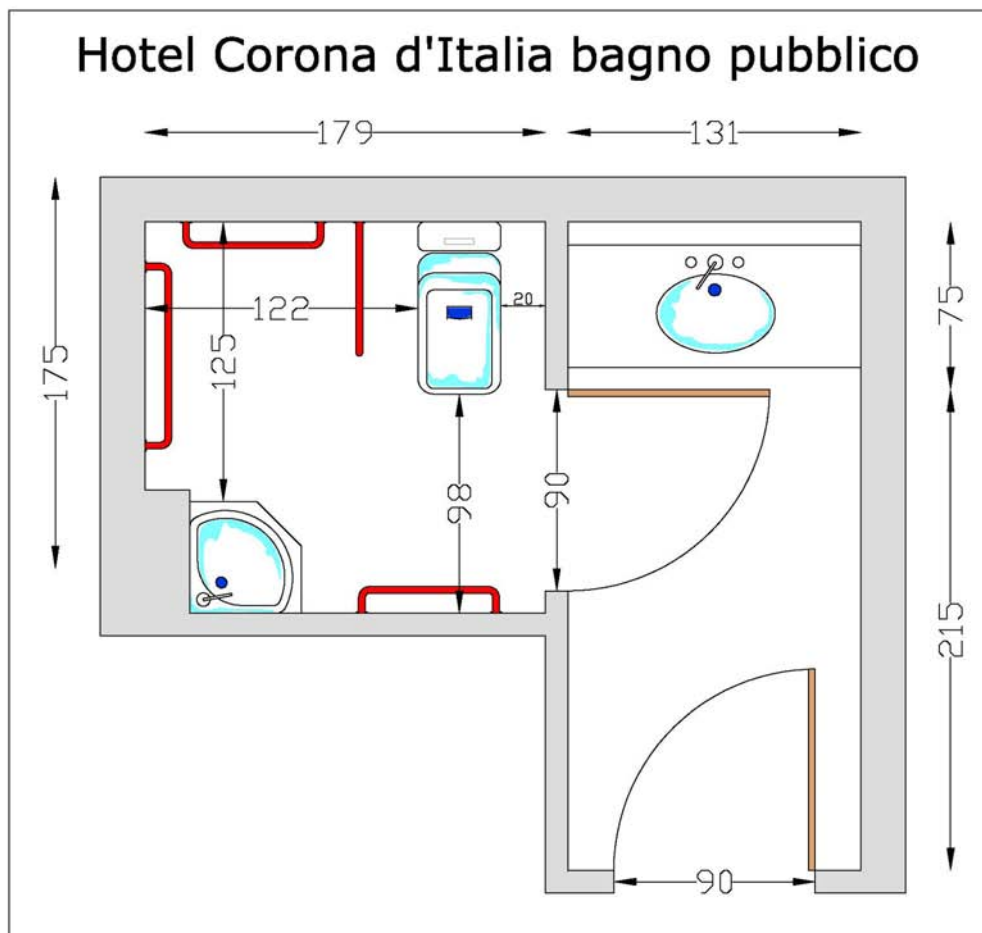
Which side of the structure does the floor plan refer to?

In: public

Situated on floor: ground

Restroom
