Name **HOTEL DECO'**

GENERAL SUMMARIZING NOTES DESCRIBING THE STRUCTURE

Decò Hotel is located on the second floor.
The access is influenced by a stairway accessible through a stair lift that can accommodate only wheelchairs up to 59 cm wide.
The stair lift leads to the first floor where a freight elevator to the second floor.
On the second floor are the reception desk, breakfast room and TV room. The hotel is equipped of an accessible room with bathrooms inside. Inner mobility is influenced by narrow ambiances and not easy to movements, the escape way leads to the elevator and to the main stairway outside of the hotel.
The hotel has an agreement with a paying garage parking service that picks-up/return the car on demand

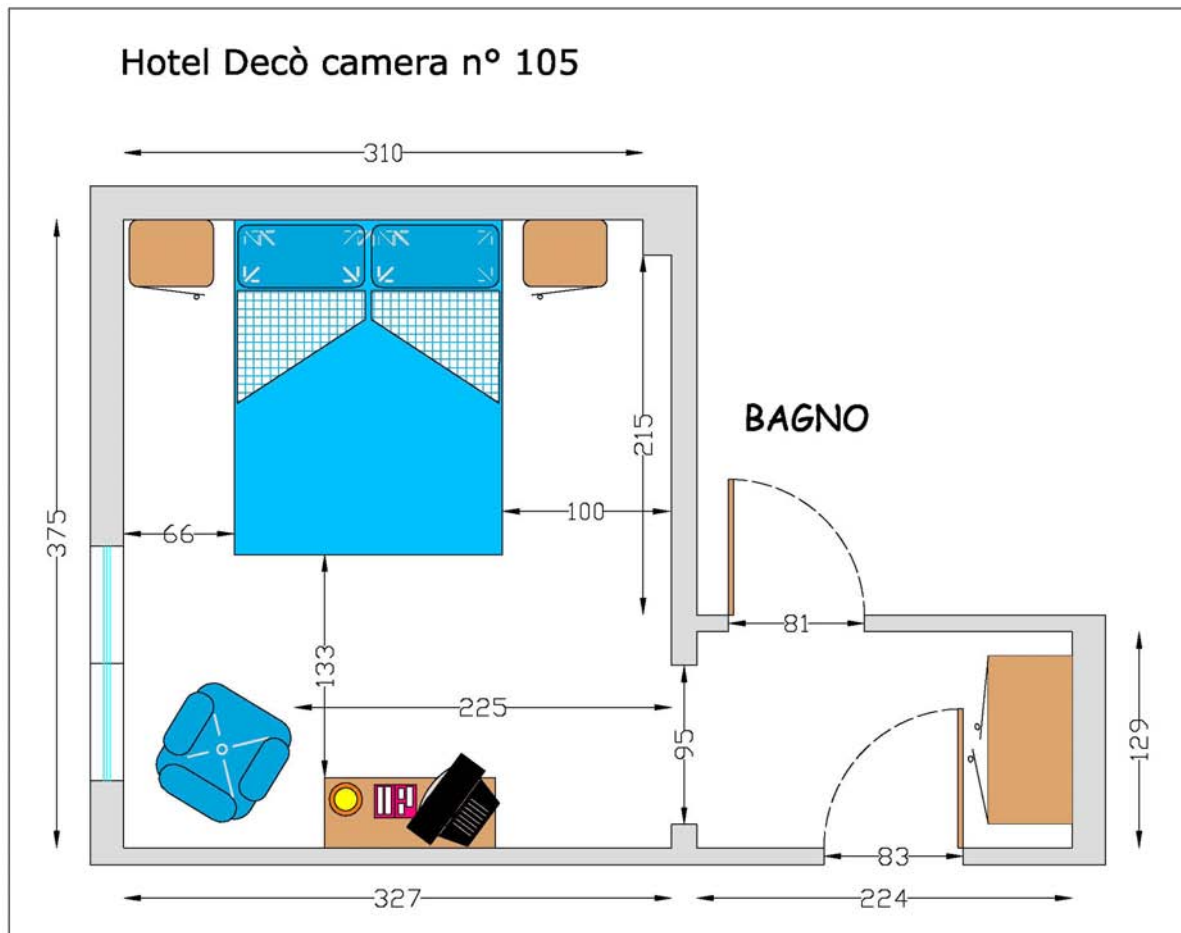
Number - Name: 105

Width of entrance door cm 83

Narrowest passage, cm 7

Description: between the wall and the bed

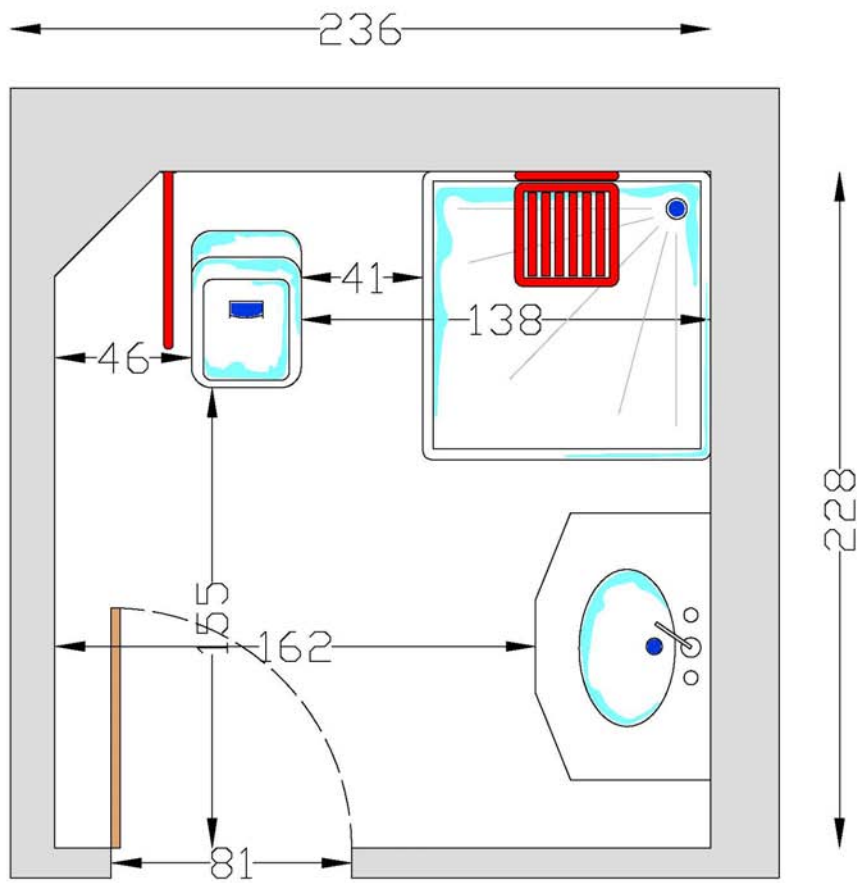
Hotel Decò camera n° 105

Type of shower: on floor with raised step cm.

3cm

Shower provided with seat? Yes

Type: drop seat

Shower provided with handles? No
