Recording date: 2/3/09

Type **Hotel**

Name **HOTEL LEONARDO DA VINCI**

GENERAL SUMMARIZING NOTES DESCRIBING THE STRUCTURE

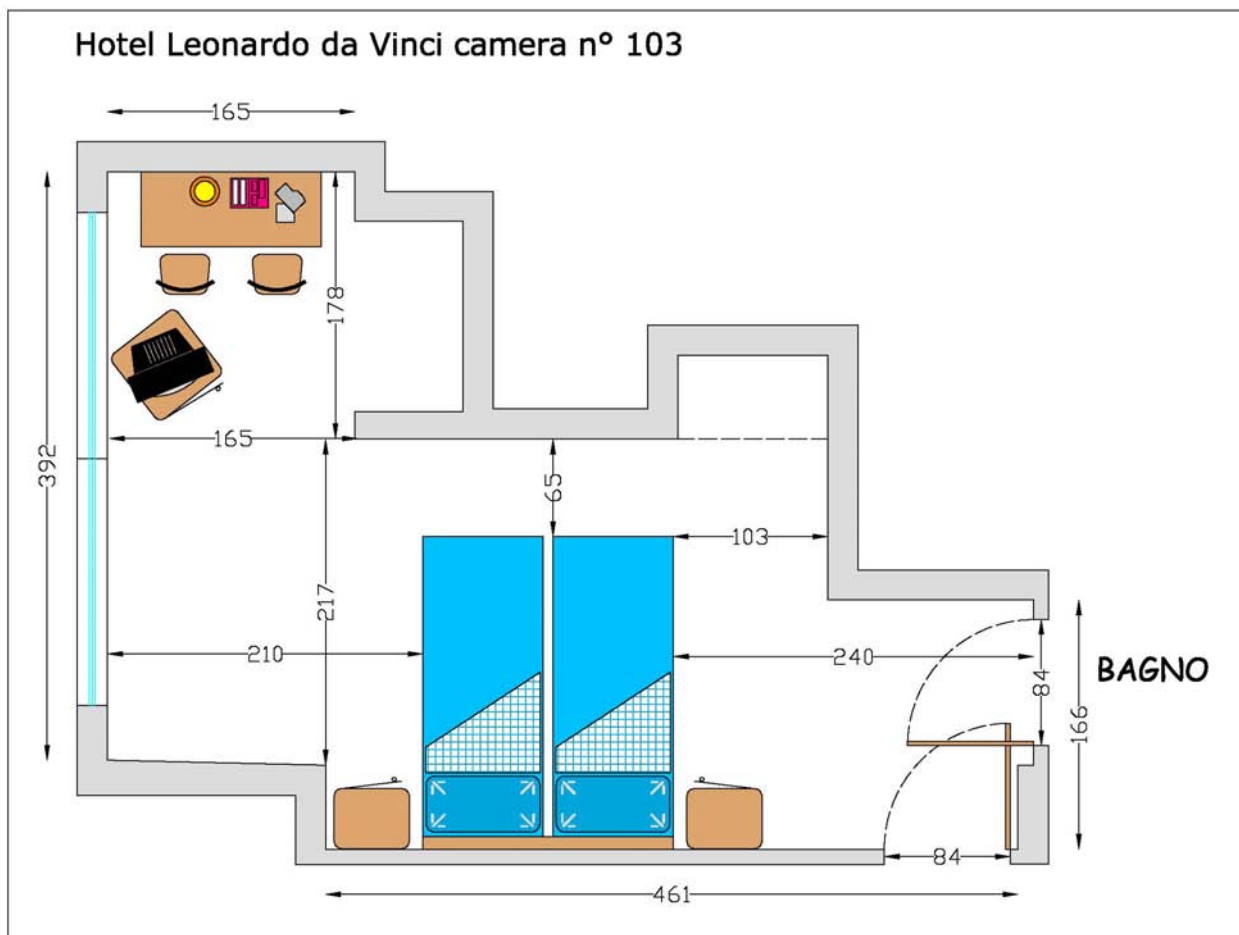
Which side of the structure does the floor plan refer to?

103

first

84

65

pathway between the wall and the bed

55

On the pathway between the lift and the room, there is a conjunction on the pavement made of a ramp: dangerous because not visible.

Accessible rooms numbers are: 103, 203 similar in disposition and dimensions.

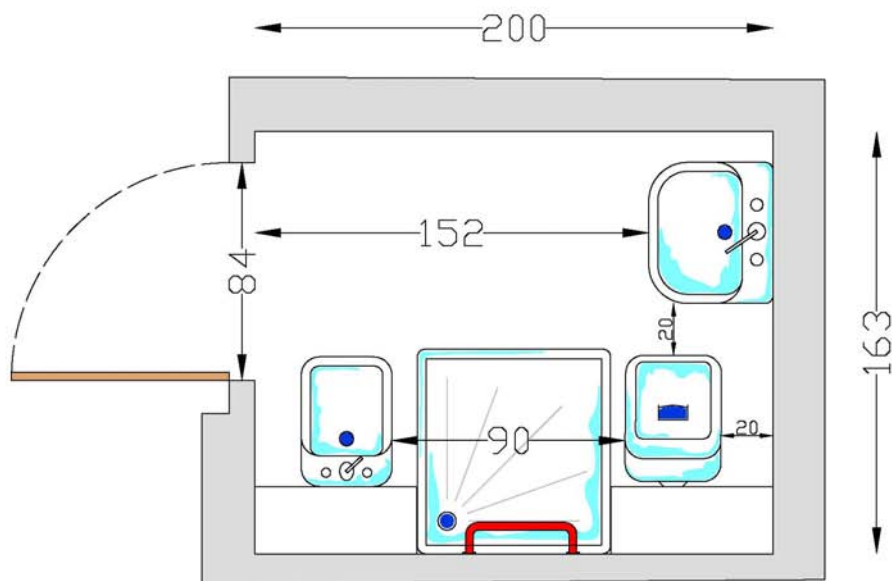
Hotel Leonardo da Vinci bagno camera n° 103

Entrance door, cm 84

Type: suspended

Type of basin faucet: lever

Space in front of the faucet, cm 152

Space in front of toilet, cm 20

Space to the right of toilet, cm 20

Space to the left of toilet, cm 90

Height of toilet, cm 45-47

Handles to the left of toilet? Yes

Shower?	Yes Si	
Type of shower:	on floor	
Shower provided with seat?	No	
Type:		
Shower provided with handles?	Yes

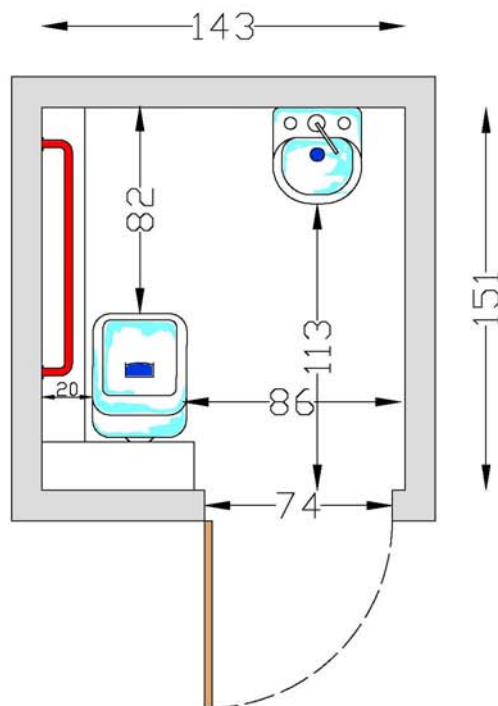
Hotel Leonardo da Vinci bagno pubblico

The public bathroom is near the breakfast/restaurant room.

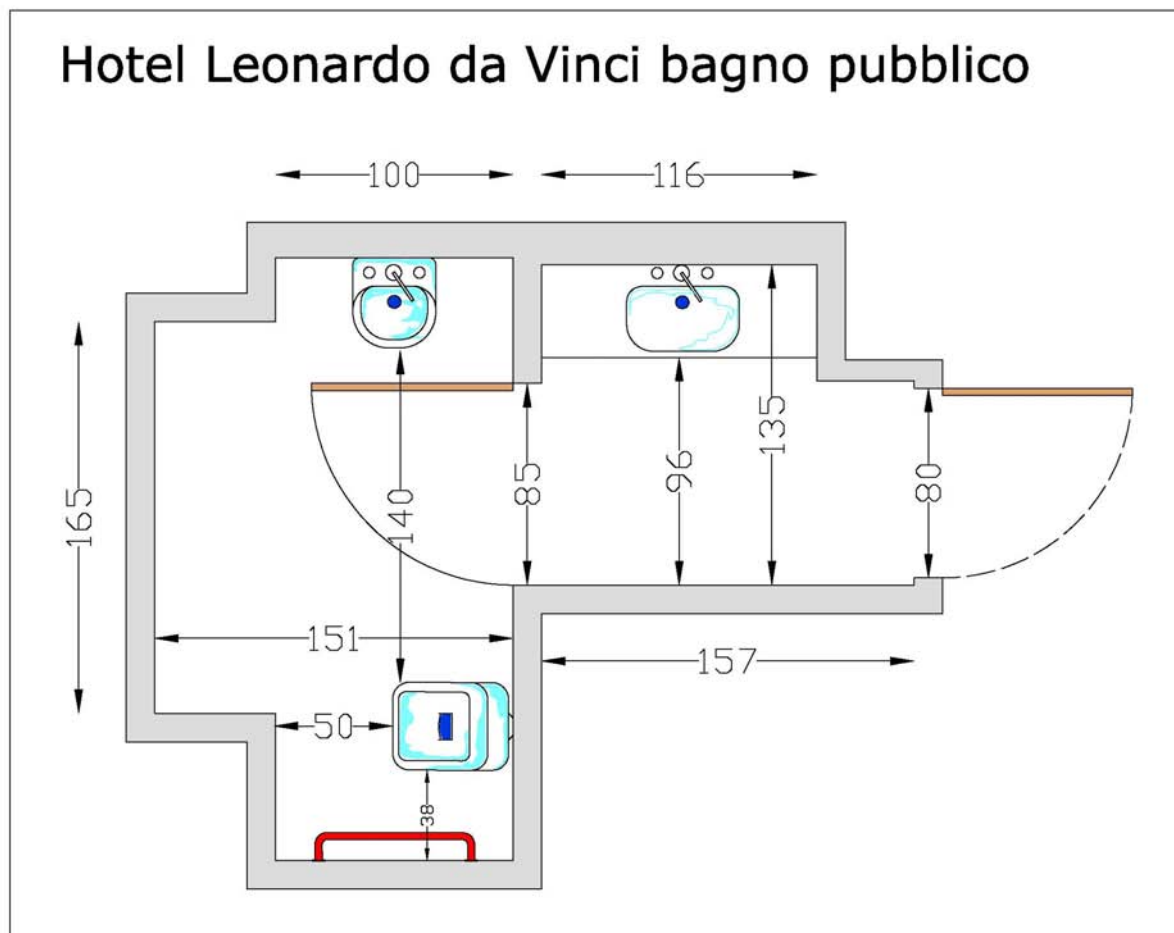
Which side of the structure does the floor plan refer to?

Yes

80

85

50

140

38

45-47

No

The public bathroom is near the breakfast/restaurant room.
